DEPARTMENT OF TRANSPORTATION**DIVISION OF ENGINEERING SERVICES**

Contract #: 04-0120F4Cty: SF/ALA Rte: 80 PM: 13.2/13.9File #: 1.28**WELDING INSPECTION REPORT****Resident Engineer:** Casey, William**Address:** 333 Burma Road**City:** Oakland, CA 94607**Report No:** WIR-027146**Date Inspected:** 06-Feb-2012**Project Name:** SAS Superstructure**Prime Contractor:** American Bridge/Fluor Enterprises, a JV**Contractor:** American Bridge/Fluor Enterprises, a JV**OSM Arrival Time:****OSM Departure Time:****Location:** Job Site**CWI Name:** Salvador Merino**CWI Present:** Yes No**Inspected CWI report:** Yes No N/A**Rod Oven in Use:** Yes No N/A**Electrode to specification:** Yes No N/A**Weld Procedures Followed:** Yes No N/A**Qualified Welders:** Yes No N/A**Verified Joint Fit-up:** Yes No N/A**Approved Drawings:** Yes No N/A**Approved WPS:** Yes No N/A**Delayed / Cancelled:** Yes No N/A**Bridge No:** 34-0006**Component:** OBG Components**Summary of Items Observed:**

WELDING INSPECTION REPORT

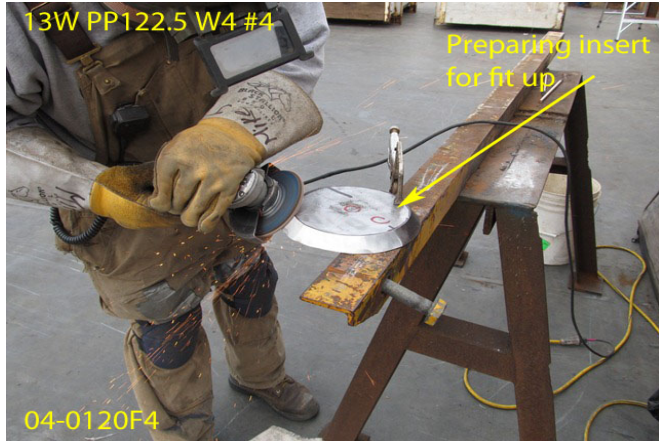
The QAI observed that welder Mike Jimenez, was observed preparing the fit-up for lifting lug hole 13W PP122.5 W4 #4. The welder had ground the edges of the hole and was preparing the insert to be fit up. This QAI observed that a copper plate was used as backing for this location as defined in Welding Procedure Specification (WPS) ABF-WPS-D15-1050A-CU. The QC inspector Steve Jenson verified the fit up for this location and found it to be acceptable, this information was relayed to the QAI. The welder then pre-heated the area prior to welding using a weed burner at 40 degrees Celsius (150 degrees F) which was verified using a tempstik and infrared gun by the QC. The welder was using the Shielded Metal Arc Welding (SMAW) using electrode E7018 for the Complete Joint Penetration weld in the flat (1G) position with 3.2mm electrode for the root and hot pass with 152 amps. The welder was using a chipping hammer, power grinder and power wire wheel for the interpass cleaning. The QC inspector for this location was Salvador Merino and was observed verifying and documenting the welding parameters for this location, along with overseeing the welding operations. At the time of the observations no issues were noted by the QAI.
